VANGUARD LOFTS
Chicago Facade Ordinance Critical Examination

1250 West Van Buren
Chicago, Illinois

Final Report
9 August 2006
WJE No. 2006.0847

At the request of First Properties LLC, Wiss, Janney, Elstner Associates, Inc. (WJE) performed a façade inspection for the building at 1250 West Van Buren Street, in Chicago. The purpose of the inspection was to fulfill the requirements of Chapter 13-196 of the Municipal Code of Chicago (the Chicago Façade Ordinance) currently in effect which includes the identification of visibly unsafe and imminently hazardous conditions that need to be immediately addressed, as well as the identification of existing conditions that may require repairs in the near future.

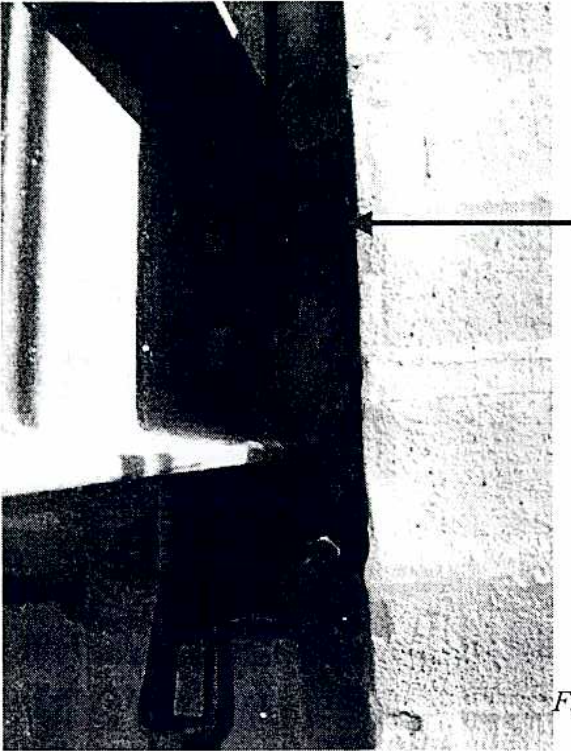
- The wood decking was fastened to wood nailers that have been screwed to the steel framing of the balconies. The wood decking was loose at the 4th floor, west-most balcony, along the south elevation, as the nails had appeared to pull out and the deck boards had curled up, see Figure 19.
- The steel framing, railing, and balusters of the balconies appeared to be in good condition. Some small areas of surface corrosion were noted where the paint was chipped or cracked.
- At the 4th floor balcony at the southeast corner of the building, WJE noted that one of the anchors securing the support plate to the masonry wall was missing and sealant was installed where the pre-drilled hole in the anchor was located (Figure 9).

Figure 9. Mounting plate with missing bolt

1. The cracked window pane, two broken glass blocks, and five cracked glass blocks should be removed and replaced.
2. The condition of the missing anchor bolt at the 4th floor balcony at the southeast corner of the building should be addressed. Due to the fact that the original anchors were tied into the floor structure, an alternate anchoring system may be required. This should be investigated by a licensed structural engineer.
3. The nut to the clevis through-bolt at the 7th floor of the north elevation should be installed.

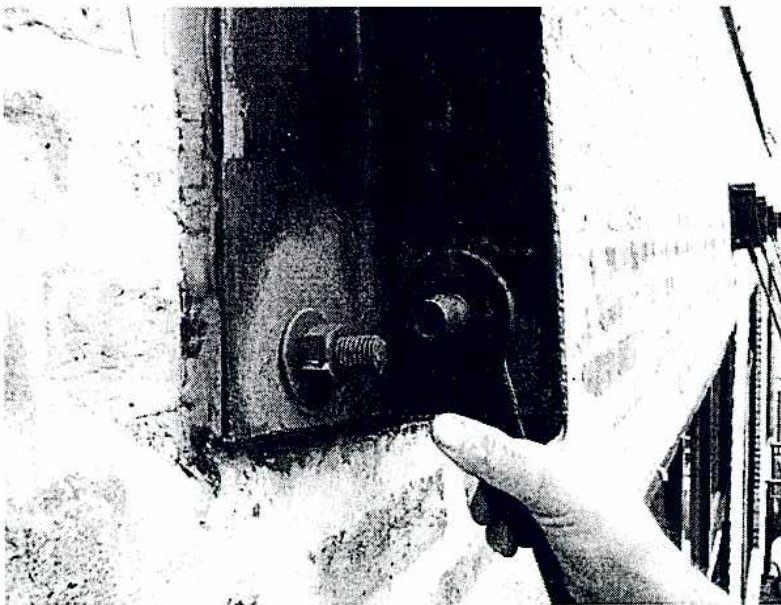
- At the 7th floor along the north elevation, 4th balcony from the west façade, WJE noted a missing nut for the clevis through-bolt (Figure 10).

Figure 10. Missing nut at clevis through-bolt

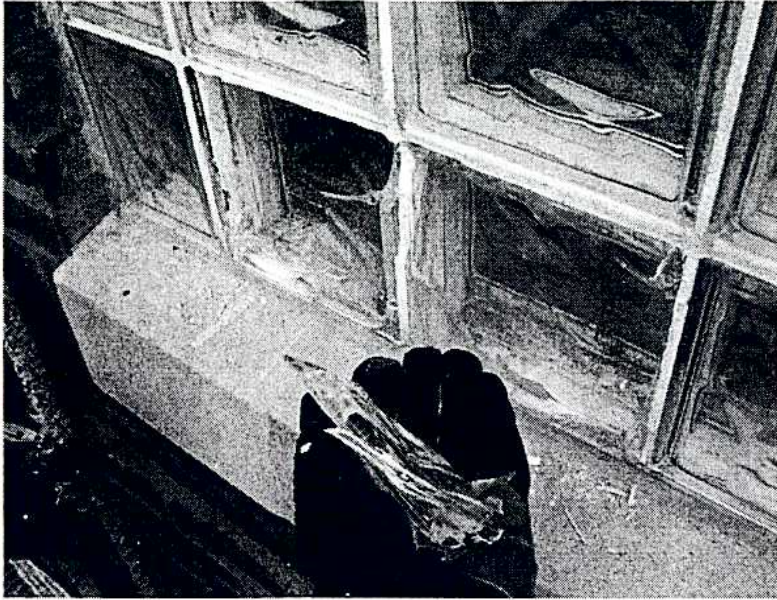
Figure 11. Broken glass blocks at the 6th floor of the west elevation.

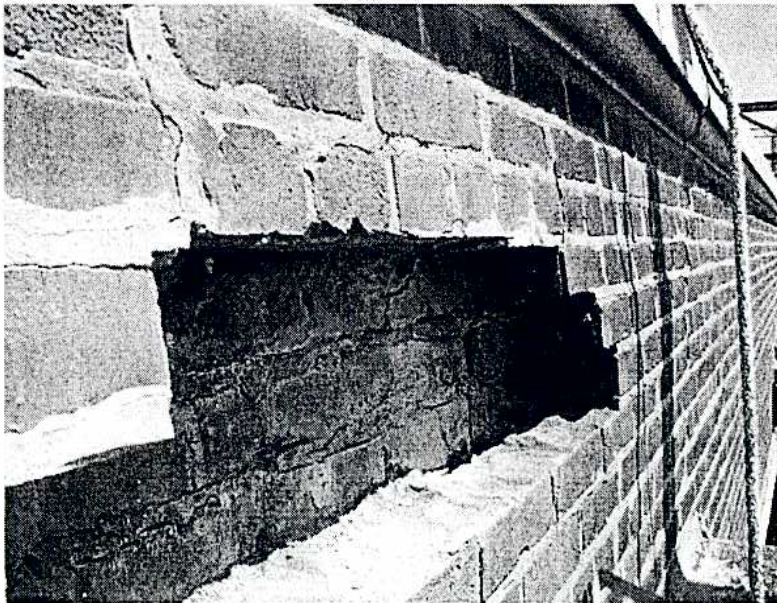
- The masonry at the parapets is in poor condition. Sounding the masonry within the parapet illustrated probable deterioration of the mortar in many locations. There is also displacement in select areas of the parapet and the overall parapet is slightly leaning towards the roof. Moisture expansion of the brick masonry has also led to bowing of the parapet walls near the corners of the building. Inspection openings were created at the parapet at the west and south elevations. WJE found that the brick units were in good condition and the header courses were not cracked, though the mortar was found to be deteriorating and in poor overall condition (Figure 12).

Figure 12. Inspection opening at parapet along south elevation.

1. Rebuild deteriorated and displaced sections of masonry along the west end of the south elevation parapet and at bowed areas above the 7th floor window openings on the north elevation. The extent of work may increase from that which is shown as backup conditions are not fully known at this time. Areas of parapet which are to remain should be ground out and tuckpointed along the interior and exterior faces for additional stability and durability.
2. The cracked or broken clay tile copings at the penthouse should be replaced and further investigation should be performed to determine the integrity of the existing stained and potentially decayed wood beam at the northeast stair tower.

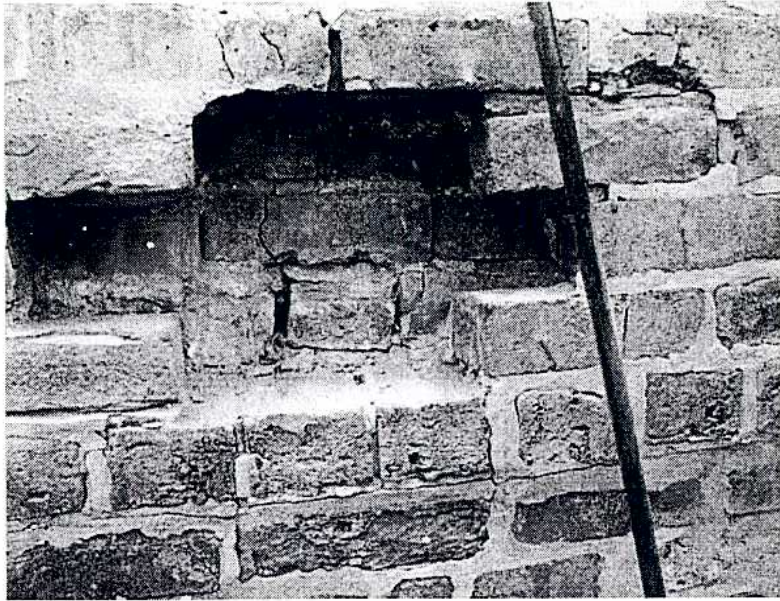
- Similar to the west and south facades, the masonry parapets are in poor condition. Similar signs of leaning and bowing related to moisture expansion were observed. The masonry has bowed out at several locations above the 7th floor window heads. Despite this condition, no mortar was cracked, illustrating that the movement was not recent. Sounding the masonry at the parapet also illustrated probable deterioration of the mortar in many locations. The opening conducted at one location in this parapet revealed substantial deterioration of the mortar, see Figure 13.

Figure 13. Inspection opening at parapet along north elevation.

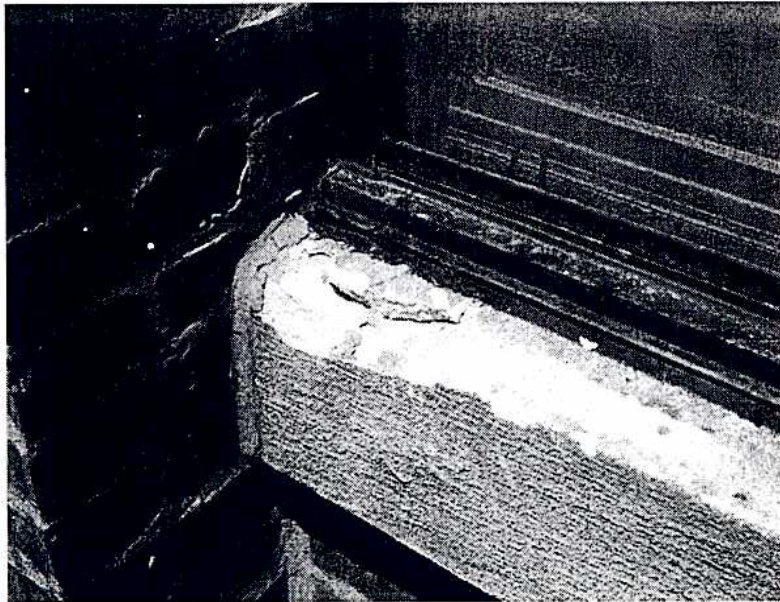
Figure 14. Isolated area of spall in limestone sill.

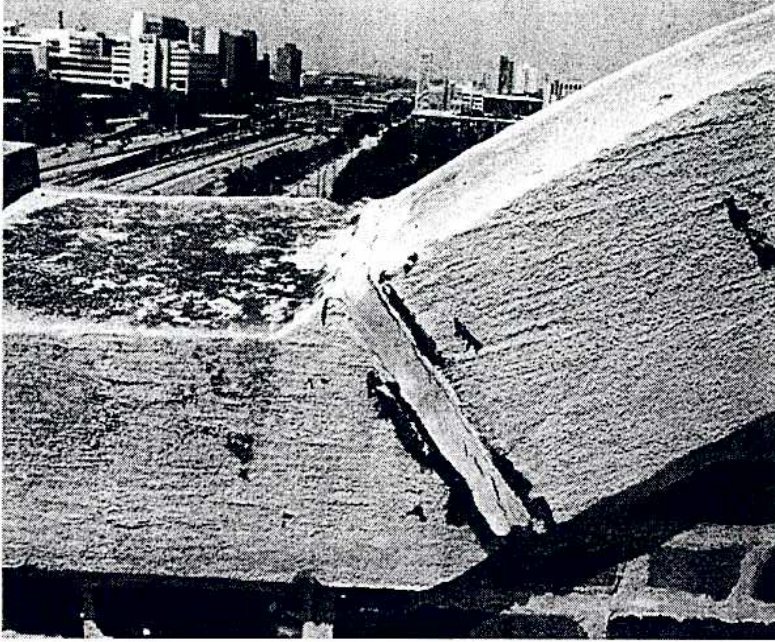
Limestone was present at the following areas: coping units, decorative pier caps along the west and south elevation, water table above the second floor at the west and south elevations, and window sills along all elevations. Generally, all visible limestone was in good condition. Very few cracks were located within the limestone units themselves, and WJE located only one area where the limestone has spalled (Figure 14). Mortar joints at the limestone units were in fair condition, though several cracks were found, allowing increased water into the wall system. The limestone coping units are also in good condition, but the sealant within the coping joints has begun to fail adhesively and cohesively, see Figure 15.

Figure 15. Failure of the sealant at joints in the limestone coping.

2. The joints in the limestone coping stones should be routed and sealed. The mortar at the joints in the clay tile coping joints should be removed and replaced with sealant. The cracked clay tile coping units should also be replaced. This would reduce the amount of water entering the wall assembly at the parapet.

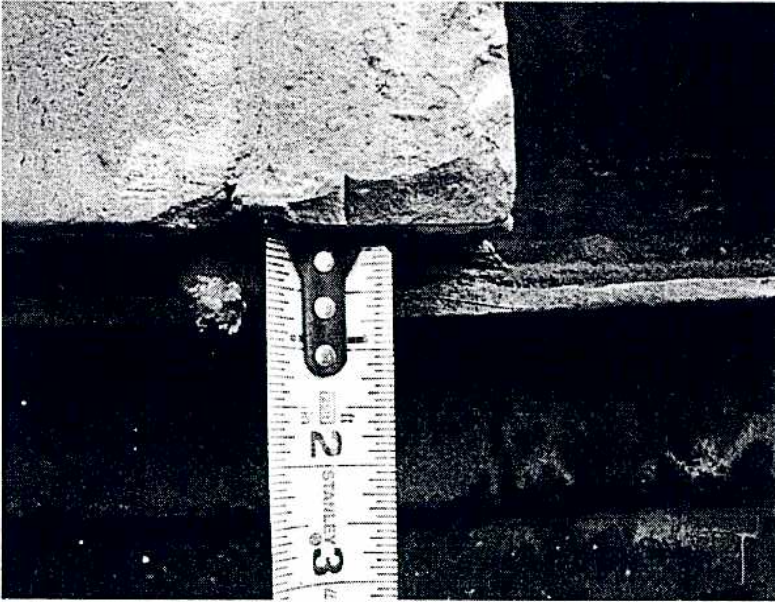
- All exposed steel lintels exhibited minor surface corrosion, due to the fact that none of the exposed steel was painted.
- Moderate rust scaling was noted at several of the original steel lintel locations throughout the building. Some of the discernible rust jacking was up to 1/2 inch thick, though no cracking or displacement of the masonry appeared to be caused by the corrosion. Inspection openings were created at two locations where an increased amount of rust scaling. These openings revealed that the remaining steel was in good condition with little section loss of the steel, see Figure 16.

Figure 16. Rust jacking at steel lintel.

1. Replace significantly corroded steel window head lintels at original window head locations primarily along the west end of the south elevation and the north end of the west elevation, and install new stainless steel pan and membrane flashing system. As mentioned above, the rust jacking at some locations will begin to cause problems within the brick masonry and the continuous loss of section of the steel lintels may create instability with the brick masonry above the lintels. The lintels should continue to be reevaluated during future inspections and examinations to identify additional repairs. We would recommend that the board consider implementing a preventative maintenance program that would include the installation of new flashings at all original lintel areas to reduce the potential for additional masonry distress and water infiltration.

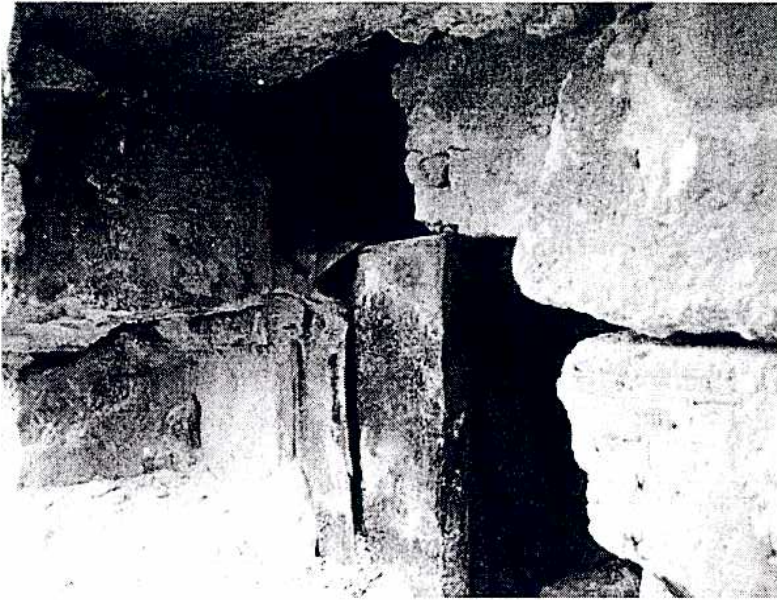
- The steel lintels that were installed during the renovation are in good condition and showed no signs of rust scaling. PVC membrane flashing with rope weeps were observed at most of these window heads, see Figure 17.

Figure 17. Steel lintel with PVC flashing membrane.

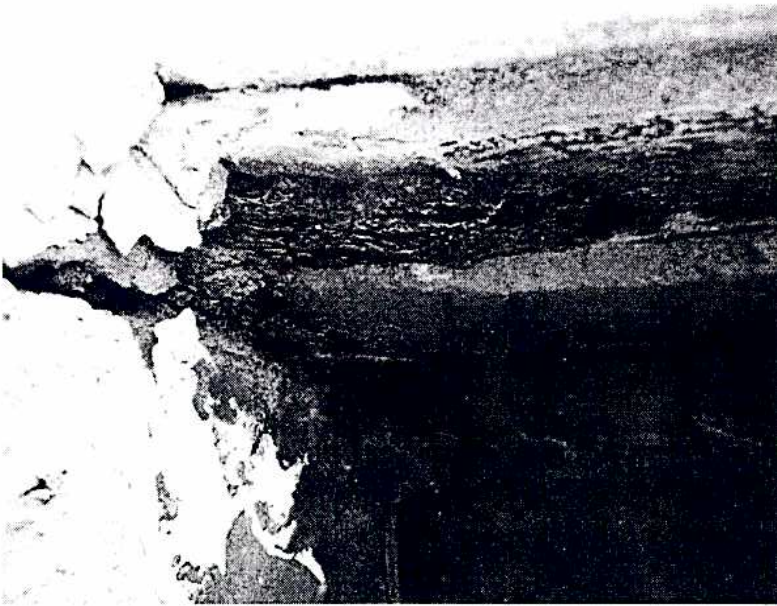
- The window lintel along the south elevation at the 7th floor, second from the west, had experienced full section loss along a 1/2 inch length of the steel plate directly adjacent to the masonry jamb, see Figure 18. Because the lintels are riveted (not loose-laid) and because the corrosion was significant at only one small area along the lintel, it is not considered an immediate safety concern, but should be addressed in the near future.

Figure 18. Corrosion of the steel lintel near the jamb

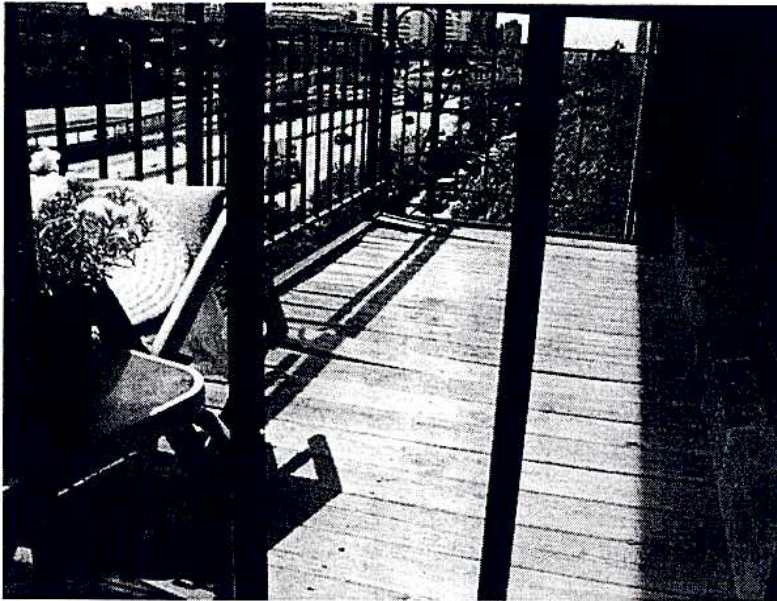
Figure 19. Wood decking curling where nails are no longer anchored into nailer below

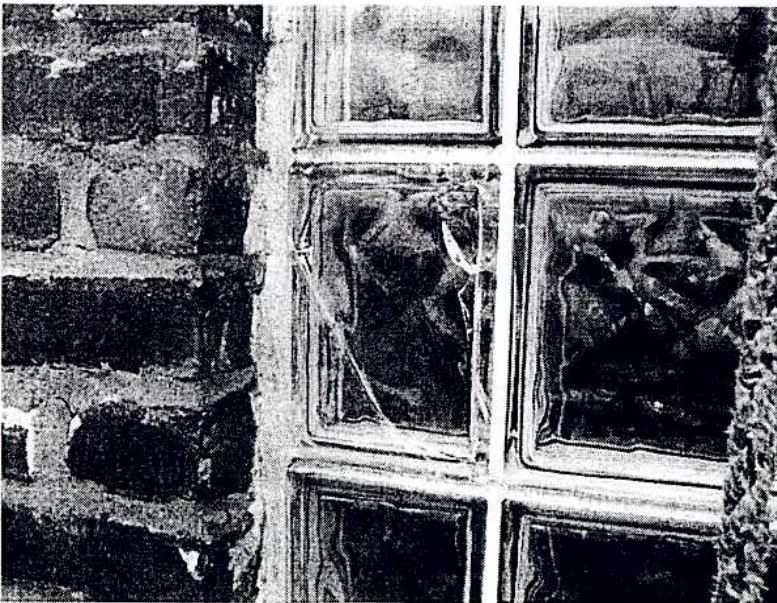
Glass block is installed along the west elevation to provide natural light to bathrooms. At locations at the 4th, 6th, and 7th floor along the west elevation, several of the exterior “panes” of the glass block are cracked (Figure 20). The cause of the cracks was not evident during the inspection, as the mortar between the blocks appeared to be in good condition and no signs of an impact were observed. Two glass blocks at the 6th floor along the west elevation are also broken. WJE removed all loose glass that was found at these units. All remaining glass block appeared to be in good condition.

Figure 20. Cracked glass block along west elevation.

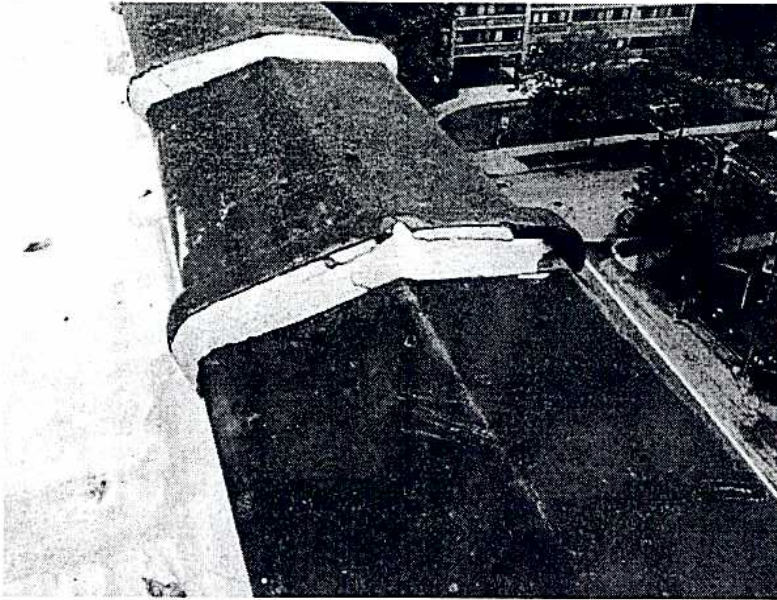
Clay tile coping is present along the north and east parapets. Most of the individual copings themselves appear to be in good condition; however, mortar was set at the laps in the copings. This mortar is cracked, loose, and is missing in many locations, see Figure 21. At several locations, the individual clay tile copings were broken and mortar was filled in where the clay tile was broken. The remaining clay tile copings appeared to be in good condition.

Figure 21. Cracked and loose mortar at lap joints in coping

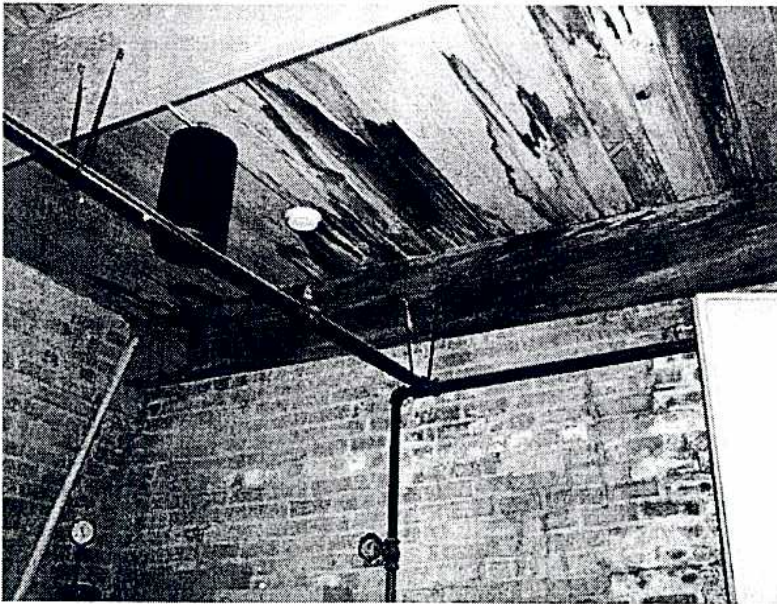
WJE observed water staining and potential decay at a roof timber at the top floor of the northeast stair tower, see Figure 22. The staining is likely due to a broken clay tile coping along the parapet above the stained wood member, see Figure 23.

Figure 22. Staining and potential decay of wood beam at top floor of northeast stair tower

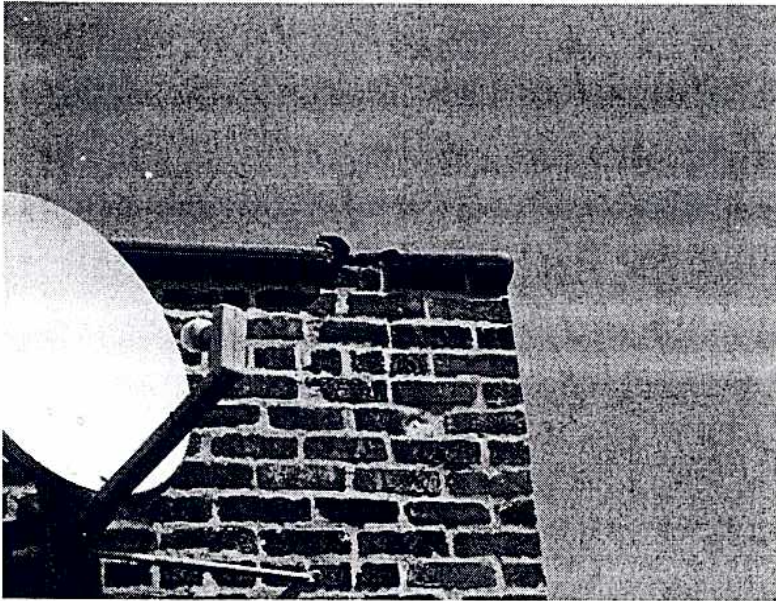
Figure 23. Broken clay tile coping above stained timber beam
